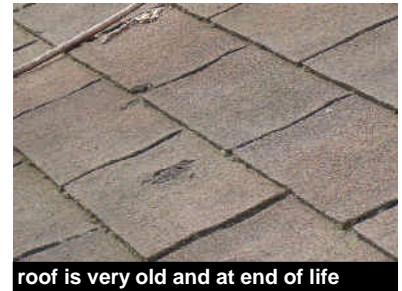
CONDITION: Roof appeared at the end of its useful life as evidenced by cracking on front face and felt showing thru on rear face..

roof is very old and at end of life

RECOMMENDATIONS: Consult a roofer for a cost estimate to replace the roof before you finalize purchase.

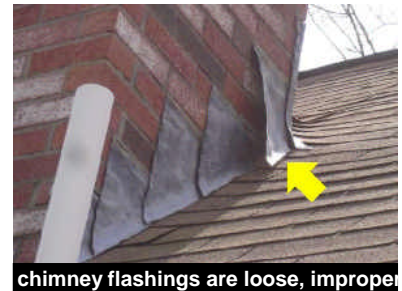
EXPOSED FLASHINGS:
TYPE: Chimney, Plumbing Vent(s)
CONDITION: Loose flashing material was noted at the chimney flashing. The flashings in this area were also cut short with no interweaving with the roof shingles. The potential for water entry appeared to be present. Plumbing flashings appeared serviceable.

chimney flashings are loose, improper

RECOMMENDATIONS: A licensed roofing contractor should be called to make further evaluation and repairs as needed.

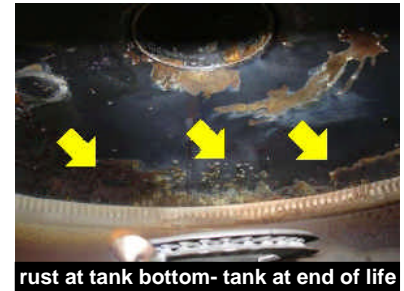
CONDITION (tank): Tank appeared to be nearing the end of its useful life, as evidenced by rust stains at the tank bottom. Water shutoff valve is: installed. Pressure relief valve: appeared serviceable. Combustion air appeared to be: adequate. Flue vent appeared to be: serviceable.

RECOMMENDATIONS: Replacement is recommended. Consult plumber.

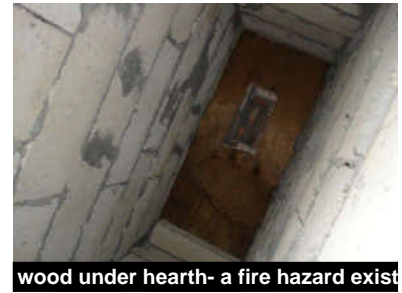
CONDITION: Wood or plywood was noted underneath the hearth. This is considered to be an unsafe condition if fireplace is used.

RECOMMENDATIONS: Consult a chimney mason for costs to remove wood. This can be expensive. Get an estimate before you finalize purchase. An alternative approach may be to have fireplace ash dump sealed up or a gas log installed.

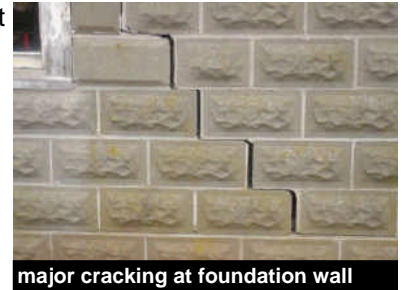
There appeared to have been some movement of walls due to settling. This has caused major cracking of the block wall. Deterioration noted to foundation walls appeared major.

major cracking at foundation wall

RECOMMENDATIONS:

A Structural Engineer should be called to make further evaluation, recommendations, and a cost estimate for repairs. Obtain this before you finalize purchase, as repairs could be expensive.

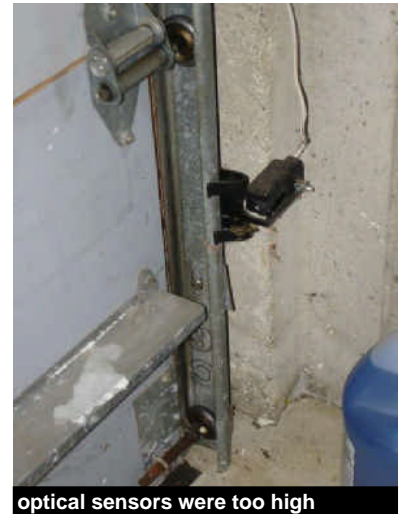
There did not appear to be safety type springs. Automatic door opener(s) were operational, however optical sensors were placed very high and denote a safety concern.

optical sensors were too high

A safety hazard exists which needs to be resolved. Adjustment of sensor height is needed. Upgrade to safety springs is recommended. Consult a garage door contractor.

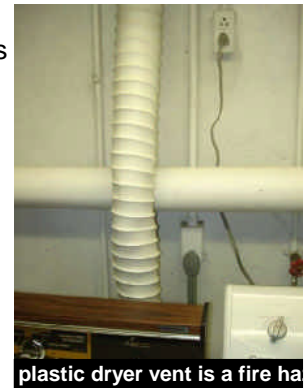
LOCATION: Basement.
CONDITION: 220 Service-operational, Electrical outlet is grounded, Plumbing appears serviceable, A plastic dryer vent was noted. Plastic dryer vents are considered a fire safety hazard.

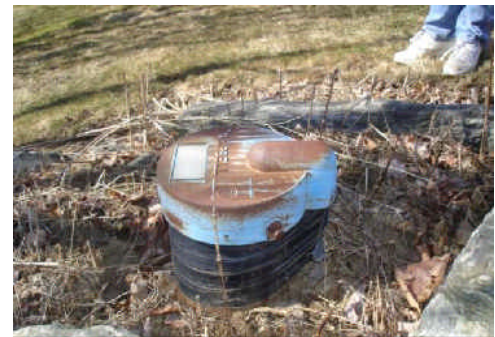
CONDITION: The well head cap is a temporary cap, not watertight, and poses a possible health risk (bacterial contamination).

temporary well cap - health concern

RECOMMENDATIONS: The sulfur smell in the water may very well be the result of contamination from sulfur forming bacteria introduced by the loose temporary cap. I recommend that you consult a well driller to disinfect the well and add a watertight cap. Get an estimate before you finalize purchase.
