## INSPECTION REPORT FOR JOHN & SARAH JONES

53 Country Road Newtown, MA

May 30, 2006

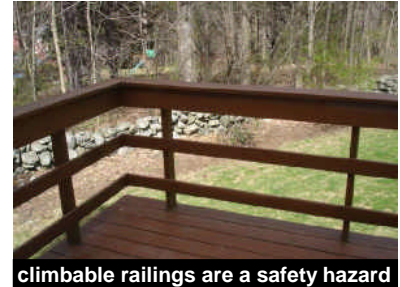
TYPE: Pressure treated wood.  
CONDITION: Handrails were climbable and present a safety hazard.

climbable railings are a safety hazard

RECOMMENDATIONS: Repairs/upgrade are needed to correct unsafe conditions. It appeared that rebuilding may be necessary. Consult a contractor.

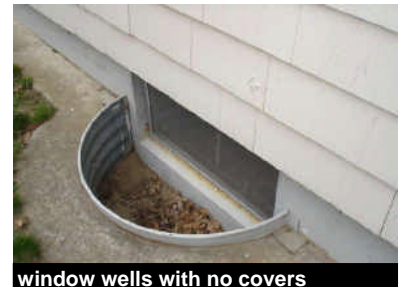
CONDITION: Covers were missing. Rainfall can collect in window wells and penetrate basement causing dampness, moisture, and/or standing water.

window wells with no covers

RECOMMENDATIONS: Add window well covers. These can either be installed by a contractor or purchased at a home center.
